BRANFORD RIVER BASIN
NORTH BRANFORD, CONNECTICUT

LAKE GAILLARD DAM
CT. 00387

PHASE I INSPECTION REPORT
NATIONAL DAM INSPECTION PROGRAM

SEPTEMBER 1978

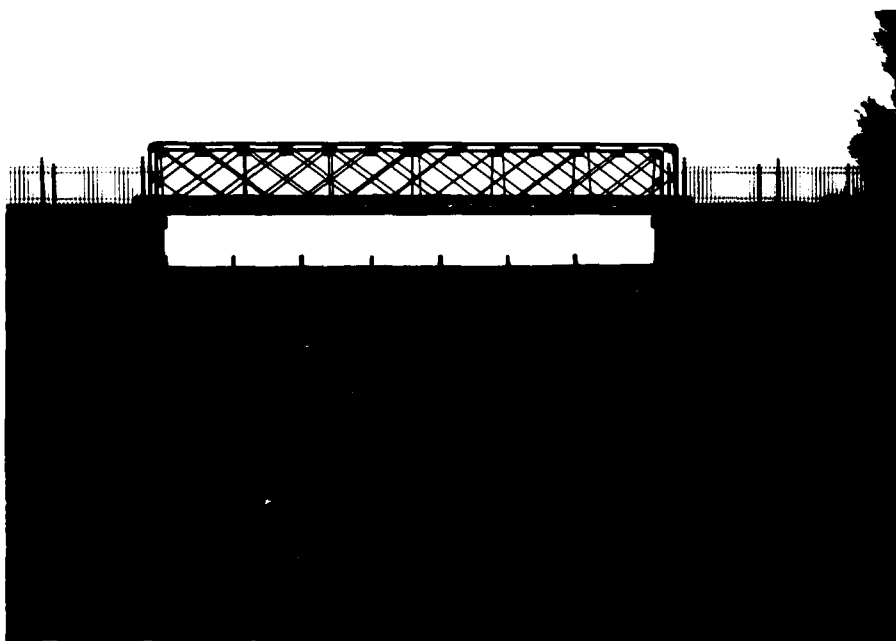
The spillway on the east dike is made of reinforced concrete and appears very sound. A steel truss pedestrian bridge with a wooden walkway spans the spillway width. The decking of the walkway has rotted and it is in need of repair.

PHOTO 2
DOWNSTREAM FACE OF SPILLWAY
